## GEOPHYSICAL INVESTIGATION FOR ROAD PAVEMENT FAILURES ON NEW EKU ROAD SAPELE, DELTA STATE, SOUTHERN NIGERIA

Avwenaghegha, O. J., Okoh, H. and Ogo, B. O.

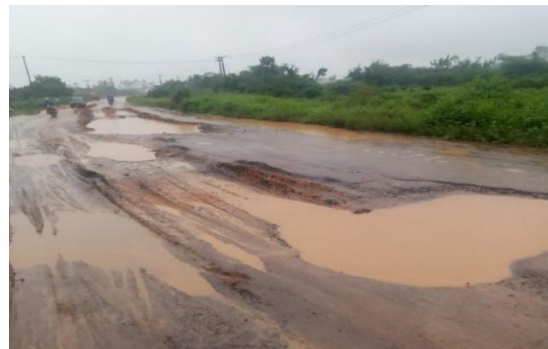
**Plate 1:** Photoshot of failed portions along New Eku Road, Sapele, Delta State, Nigeria

surface. The inversion has clearly shown that the entire area clearly depicts areas of low resistivity which could possibly be the cause of the road failure due to its suspected clayey nature. This very road section is one of the areas where the damaged road showed clear evidence of the suspected clayey soil as seen in Plate 1.

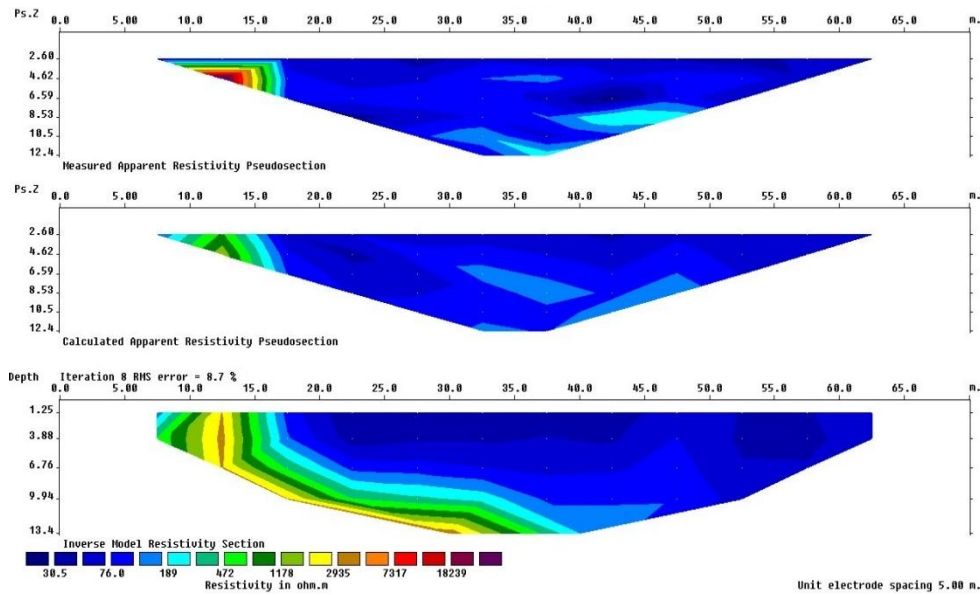
**Figure 2:** Pseudo-section plots showing the measured apparent resistivity, calculated apparent resistivity and inverse model resistivity section of profile 1

The inverse resistivity model revealing resistivity sections is shown on figure 2. It is characterized by low resistivity starting from less than  $30.5\Omega\text{m}$ - $130\Omega\text{m}$  which is seen throughout the profile length, particularly at distance 17m-60m to depths of 13.4m beneath the

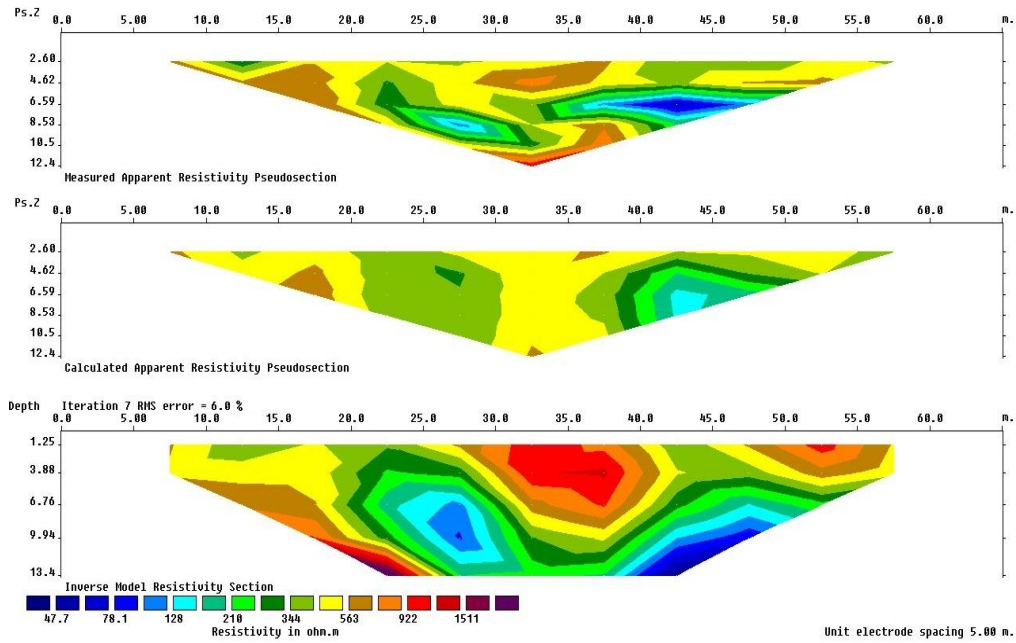
**Figure 3:** Pseudo-section plots showing the measured apparent resistivity of profile, calculated apparent resistivity and Inverse model resistivity section of profile 2

The inverse resistivity model revealing resistivity sections is depicted in Figure 3. This profile reveals an intercalation (insertion) of very low resistivity clayey subgrade with values ranging from 47.7Ωm-128Ωm and water absorbing substratum clastic rock types at an appreciable depth of about 6m downwards at the 20m-30m length of the profile and subsequently cuts across the base of the profile length. These low resistivity rock types were inferred to be sandstone, clay and clayey sands.

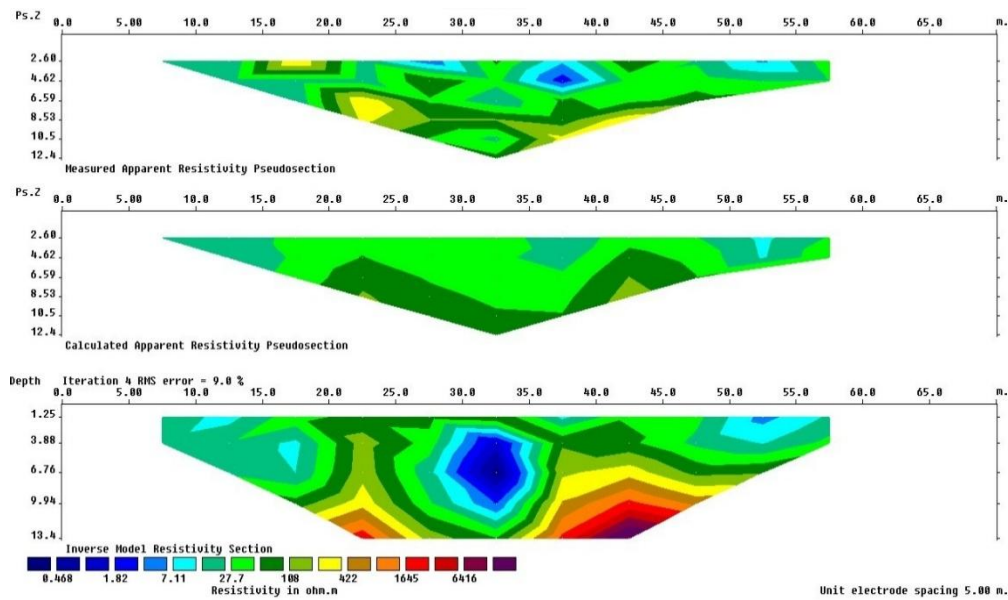
**Figure 4:** Pseudo-section plots showing the measured apparent resistivity, calculated apparent resistivity and inverse model resistivity section of profile 3

The inverse resistivity model revealing resistivity sections on Figure 4. It shows that there is a fair distribution of moderately high resistive rock types an average depth of about 9m and below. There is also water absorbing clastic rock types cutting across the whole profile length and forming the upper layer of the profile. Distinctive zones with low resistivity values ranging from 7.94Ωm-45Ωm are seen at a distance between 22m-35m and 50-58m to a depth of 7m and 9.94m respectively from the top soil. The absorption of surface water by these low resistive rocks could possibly be a reason why there is failure at this very portion since there is no competent or resistive rock to compensate for the weight of the vehicles plying this road.
