Geophysical Investigation of Bulding Distress in Gashua, Nigeria

*¹Agada, L. E. and ²Sonloye, S. A.

ABSTRACT

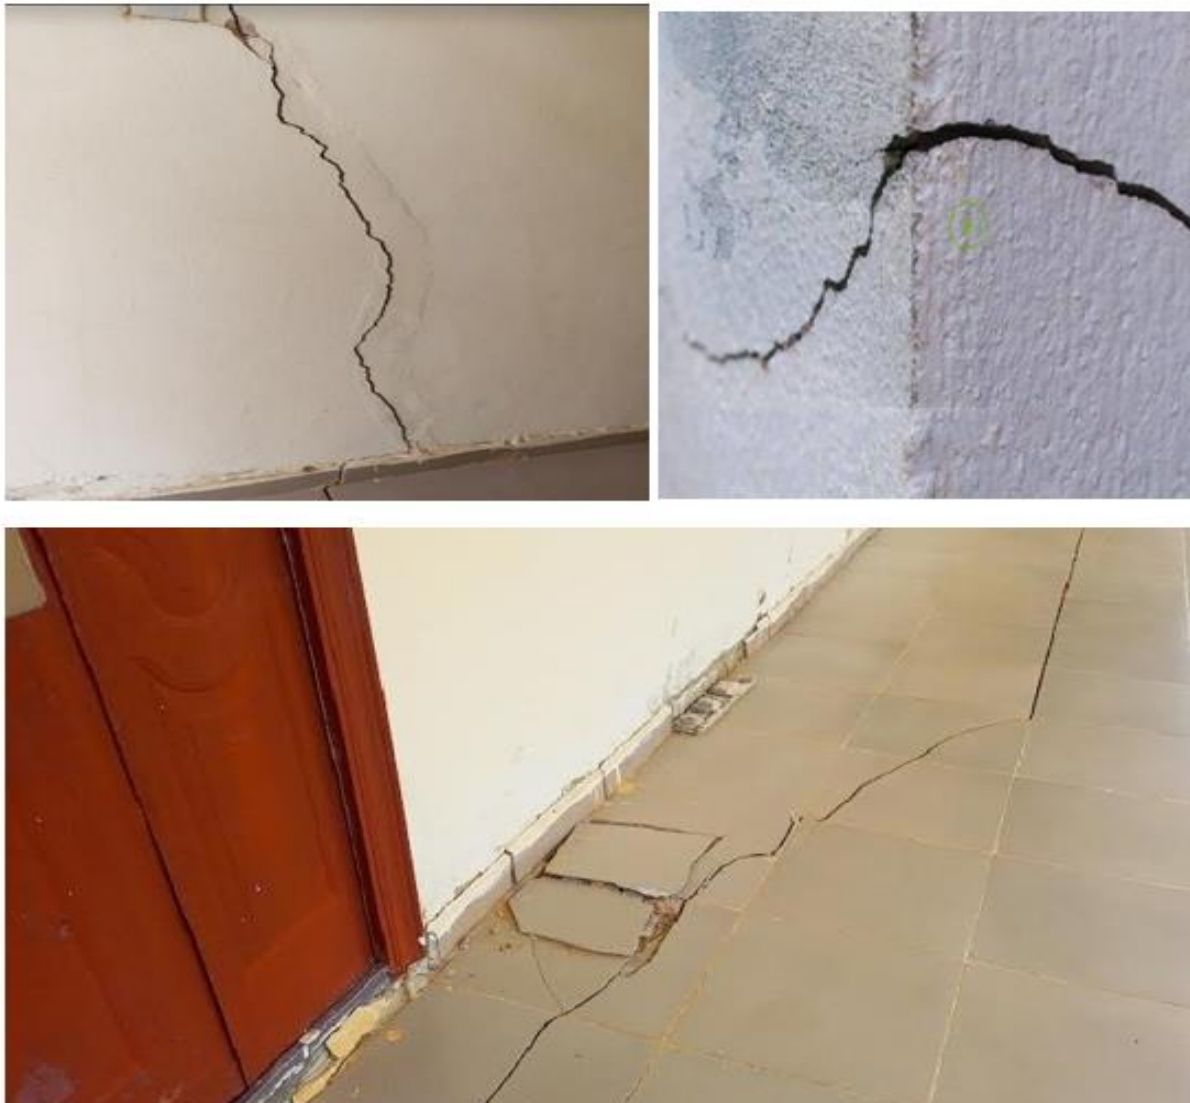
and its environs, many buildings and other civil engineering structures are mostly cited based on surface assessment of the sites without any subsurface investigation to determine the soil integrity. This is a common practice in many urban and rural areas in Nigeria and this practice has contributed to building failures across Nigeria. Figure 1 shows typical building distresses observed in the study area.

Figure 1: Common building distress leading to building failure in the study area

The increase in building collapse in Nigeria has claimed many lives and properties. The situation calls for urgent attention. It is an incident which can occur at any time depending on the amount of distress on a building (Figure 1). In Nigeria, Lagos State has the highest cases of building collapse, although the problem of building collapse occur all over Nigeria but the scale of its

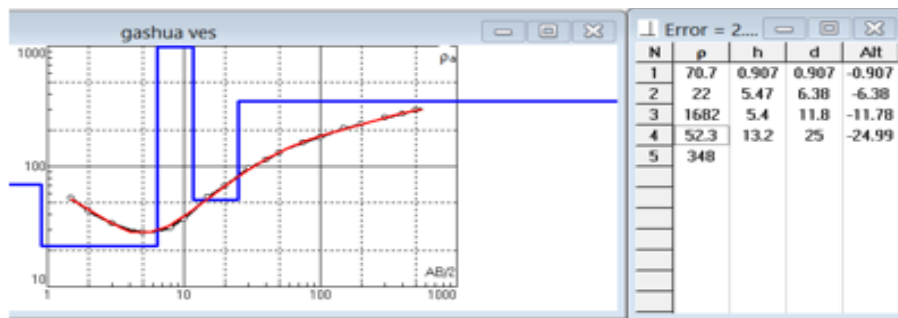
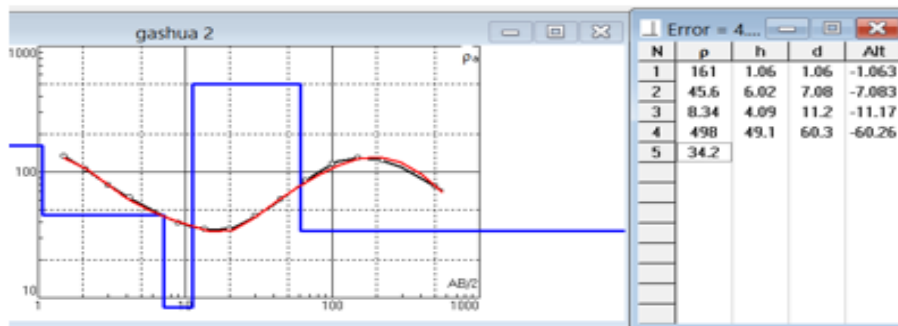
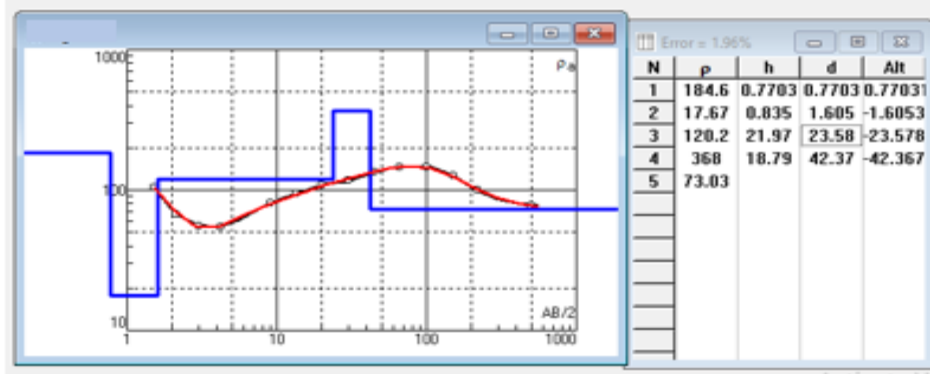
Clay soil are characterized with low resistivity values due to its conductivity. The third layer has resistivity values which ranged from 8.3 to 1682 Ω m. It has an average resistivity value of 362.9 Ω m. It is mainly a sandy formation intercalated by clay in the vicinity of VES 2 and 3 (Figure 3). The fourth layer has resistivity values which ranged from 52.3 to 498.0 Ω m. It has an average resistivity of 160 Ω m. It is mainly a sandy clay formation with the exception of VES 2 and 3 areas that were intercalated by sand (Figure 4a). It has an average thickness of 100 m. The fifth layer has an average resistivity of 262.5 Ω m. It is a sandy formation intercalated by clay at VES 2 area. In this study emphasis was on the lithology of the study area and how it impacts the buildings in Gashua and its environs.

Figure 3: Typical geoelectirc curves obtained from the study area

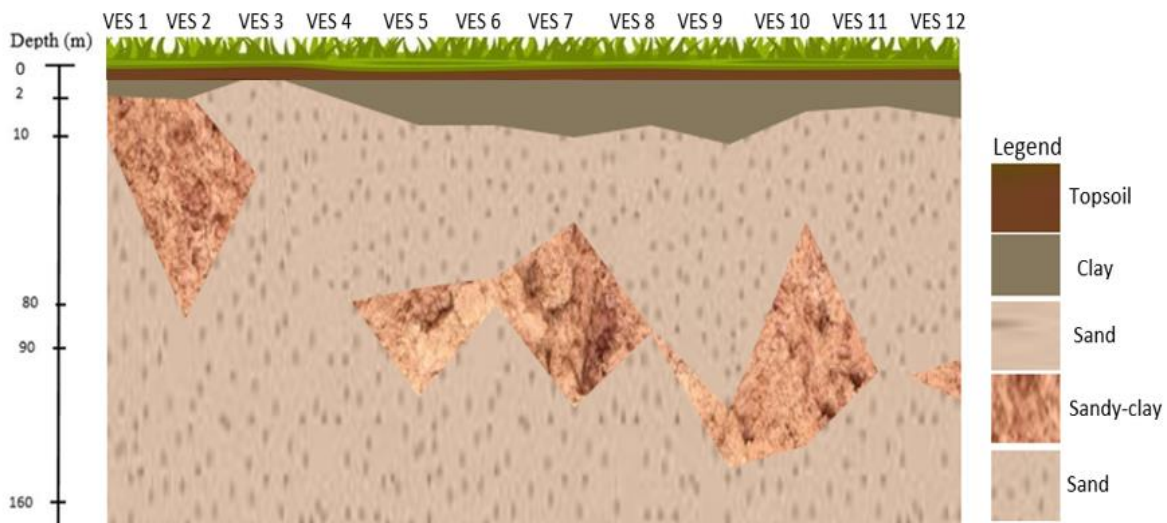
The results of the Vertical Electrical Sounding (VES) revealed that the thickness of the first layer was thin and it was underlain by a layer of clay formation.

Figure 4: Geoelectric section of the study area

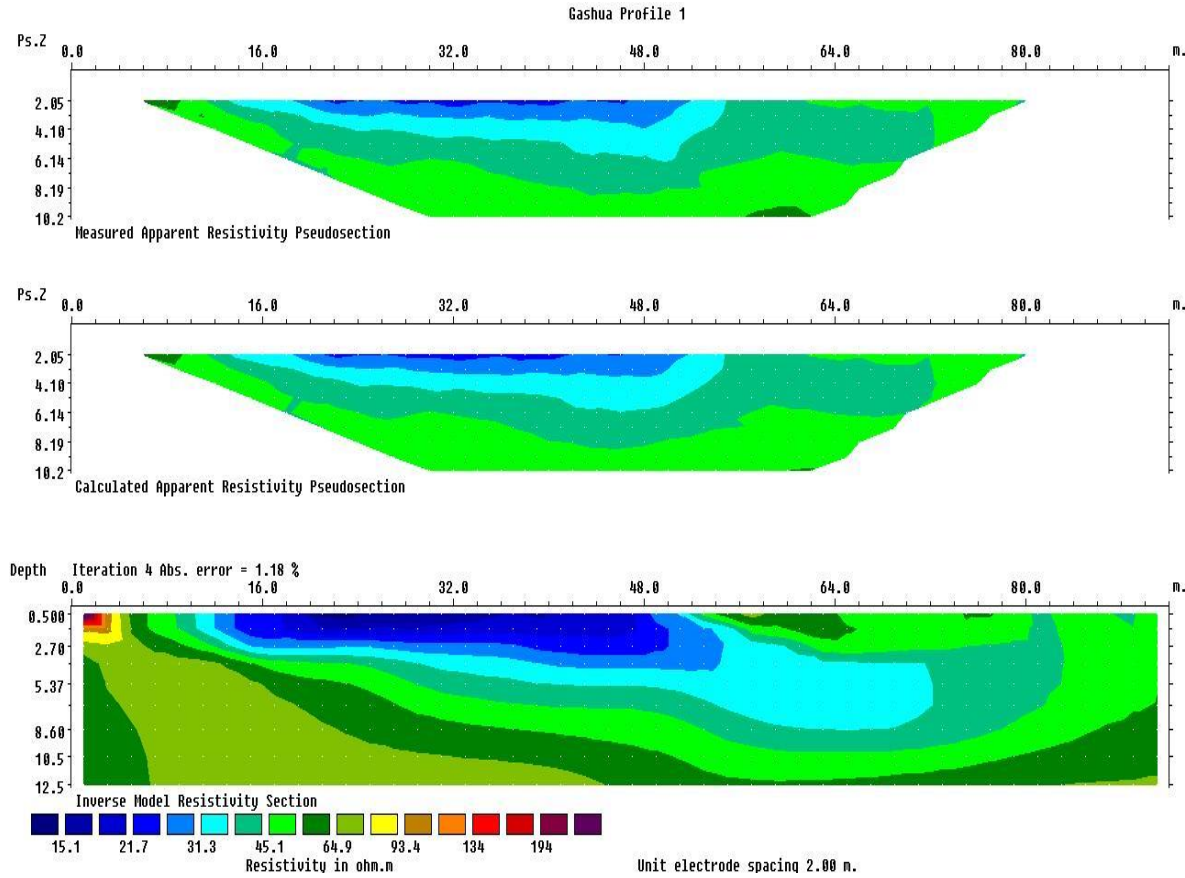
The results of the 2D electrical resistivity tomography (Figures 5a) showed that in some parts of the study area, the clay soil extends to the surface, while in the greater parts of the study area the topsoil is underlain by clay soil (Figure 5a). The 2D-ERT results correlated well with the Vertical Electric Sounding results. Some of the foundations of the buildings in the study area were situated within the clay layer due the proximity of the

clay layer to the surface of the Earth. The response of the clay formation to periodical hydrological conditions of the study area affects the buildings in the area. The contraction and expansion characteristics of clay formation which occur during dry and wet seasons often induce significant mechanical stress on buildings whose foundation are laid within the clay horizons.

Figure 5a: Inverted resistivity model of profile 1 in the study area showing the proximity of the clay layer to the Earth surface. The clay materials are indicated in blue color and they are characterized with low resistivity values which ranged from 10 - 35 Ω m

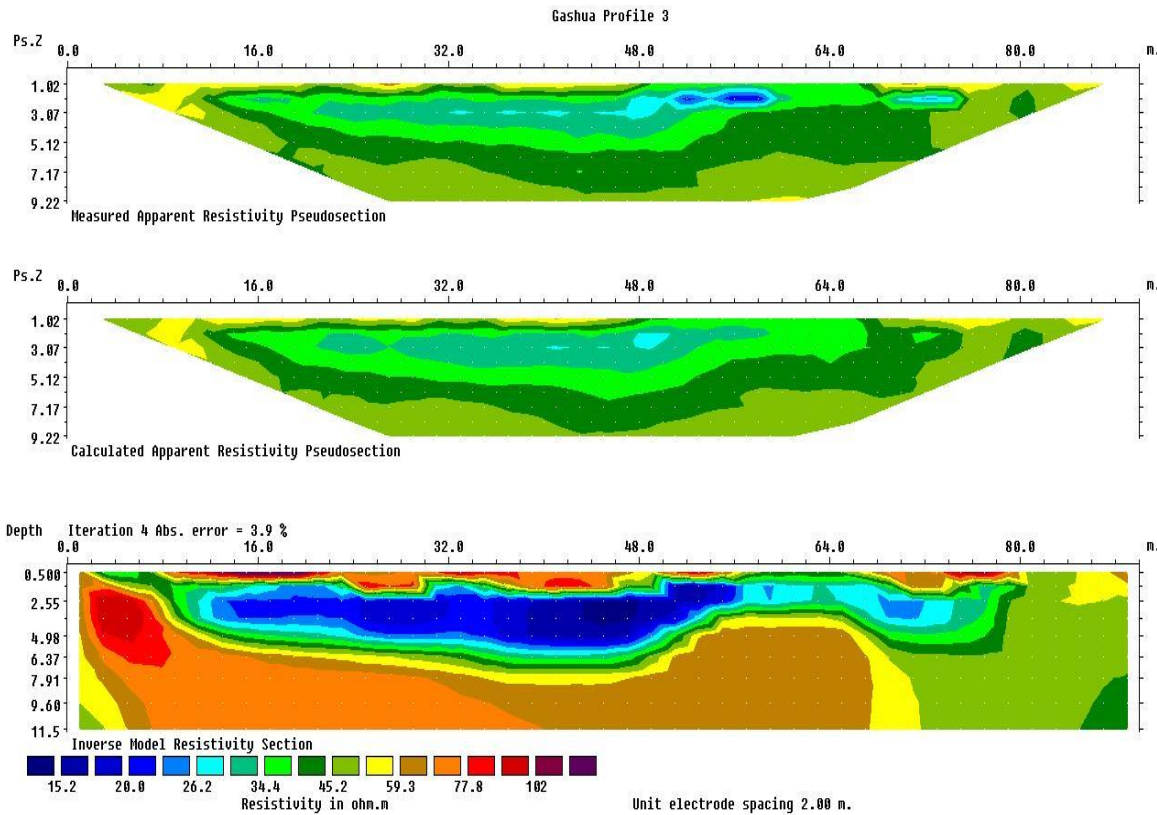
Figure 5b: Inverted resistivity model of Profile 2 showing the distribution of clay and other incompetent materials in blue color in the subsurface of the study area. These materials area responsible for building distress and failure in the study area

The nature of the foundation to be adopted for any civil engineering structure should be a function of the nature of the subsurface materials underlying the site and the type of structure to be built. Areas underlain by less competent materials requires special foundation to compensate for the load bearing capacity of the soil. The results of this study showed that the study area has a thin topsoil which is relatively lower than 1.2 m. This topsoil is underlain by a clay formation which undergoes volumetric changes due the variation in its moisture content. The volumetric changes in the size of the clay formation distorts the stability of the buildings in the study area. The results of this study showed that areas underlain by thin clay layer requires the excavation of the clay materials before laying the foundation (Figure 5a), while areas with thick clay layer and other incompetent materials need specific reinforcement and special foundation to support the buildings (Figure 5b).
