## Geophysical Investigation of Road Pavement Failure Along the Mubi Bypass Road, Jambutu, Jimeta, Yola, Adamawa State

Audu. J., \*Ike, E., Yerima, J. B. and Oniku, A. S.

Department of Physics, Faculty of Physical Sciences, Modibbo Adama University, Yola, Nigeria

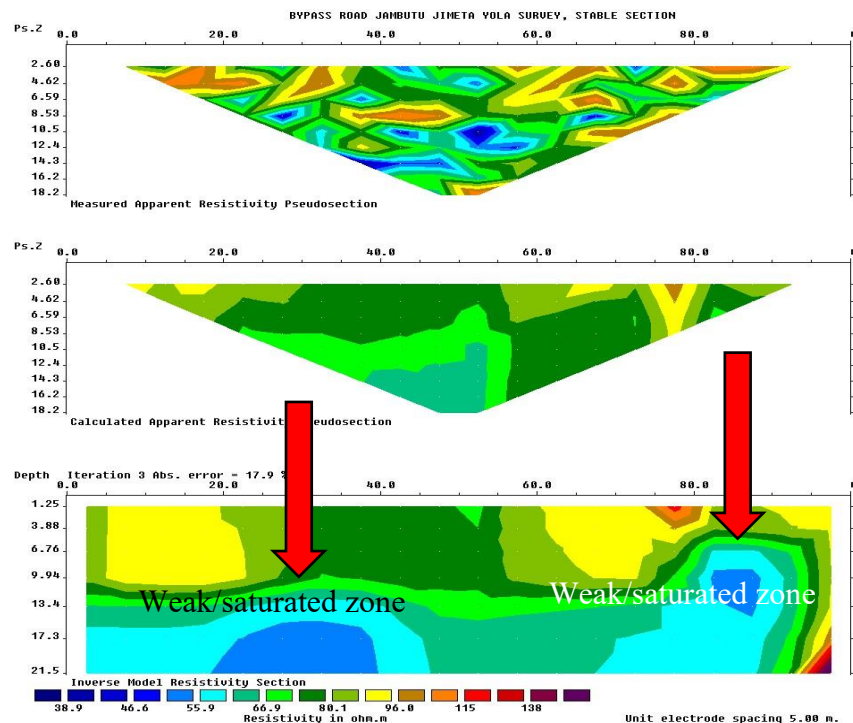
Figure 3: Pseudo-section plots showing the measured apparent resistivity, calculated apparent resistivity and inverse model resistivity section for Stable Section 1 (SS1)

Figure 3 and Figure 4 shows the resistivity pseudo-sections for the stable section 1 (SS1) and stable section 2 (SS2) respectively. The figures show resistivity values ranging between 38.9 - 138  $\Omega\text{m}$  and 28.2 - 121  $\Omega\text{m}$  respectively. These ranges of resistivity values indicate that the road sections are underlain by very hard clay, sandy clay and/or sandstone (Amos-Uhegbu & John,

2017; Oguntade, 2022; Reynolds, 1998; Telford *et al.*, 1990) and are adjudged to be moderately competent (Idornigie *et al.*, 2006). The resistivity of the stable road sections 1 (SSS1) ranging between 38.9 - 138 is typical of soils with low to moderate moisture content, high density and low porosity, good stability and load-bearing capacity. Whereas, resistivity of the stable road sections

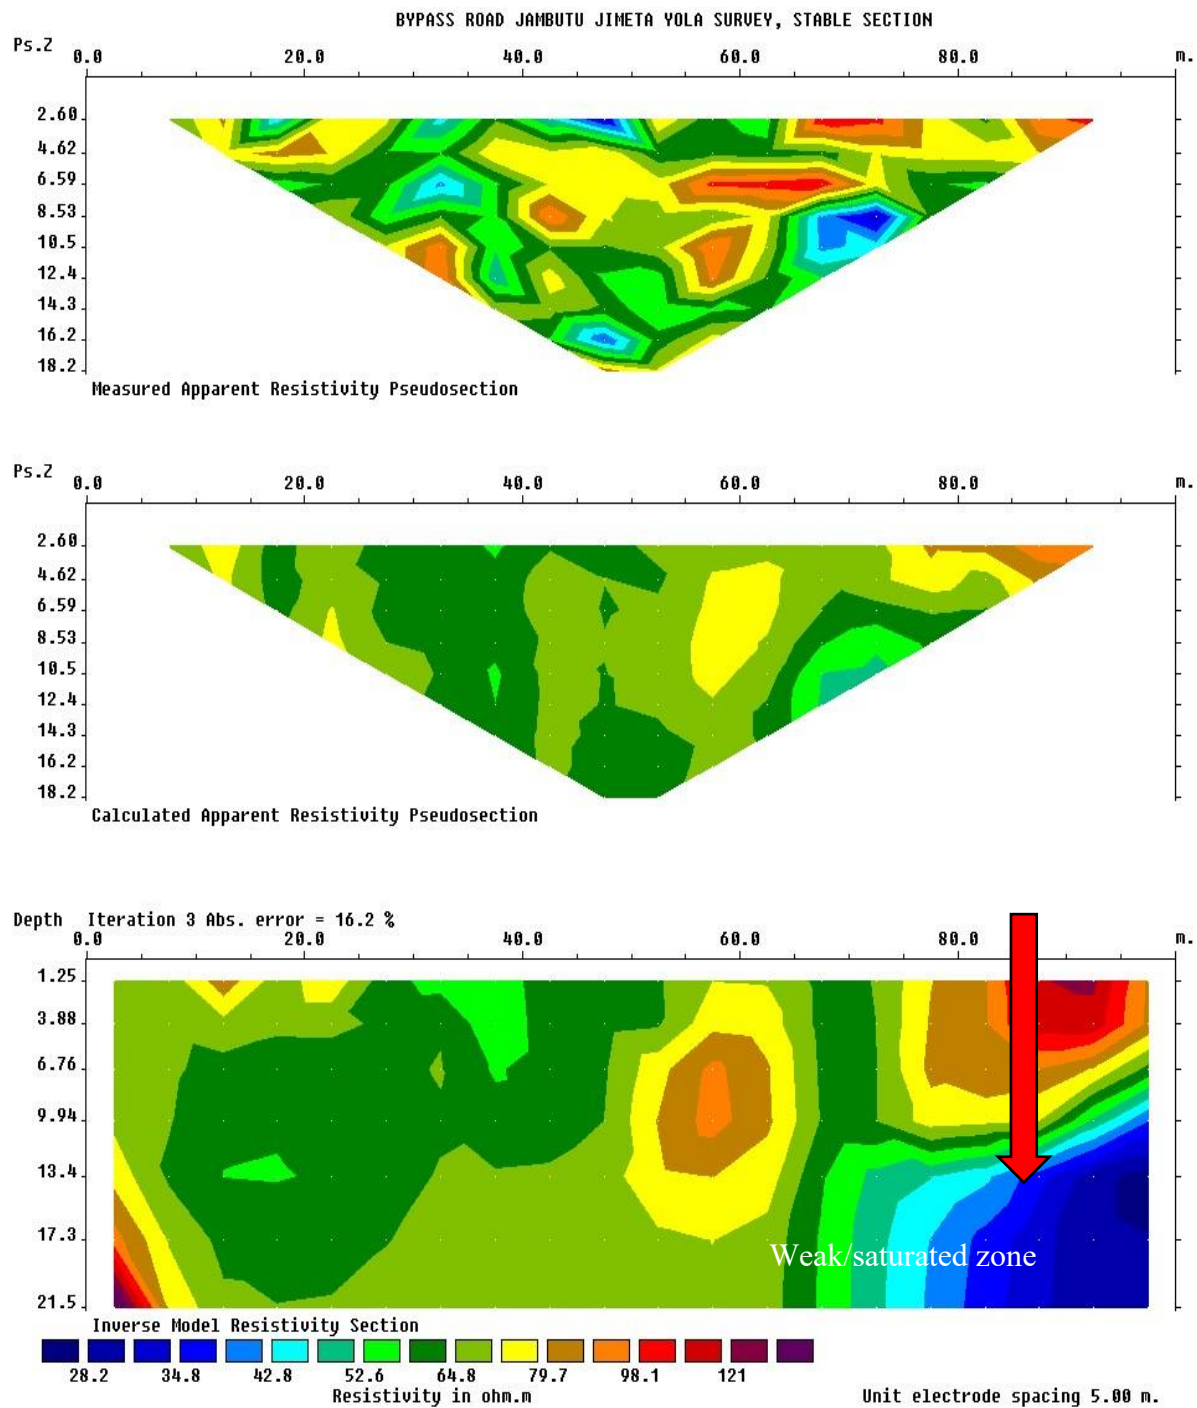
Figure 4: Pseudo-section plots showing the measured apparent resistivity, calculated apparent resistivity and inverse model resistivity section for the Stable Section 2 (SS2)

2 (SSS2) ranging between 28.2 - 121  $\Omega\text{m}$  is typical of soils with moderate moisture content, moderate density and porosity, fair stability and fair load-bearing capacity (Lowrie, 1997; Reynolds, 1998). This no doubt accounts for the relative stability of these sections of the road. We can therefore deduce that the influence of sandy clay and sandstone intercalation which are not really water bearing zones (Rafiu *et al.*, 2020) increases the shear strength of the soils and the load bearing capacity (Amos-Uhegbu & John, 2017). However, though there was no failure observed at these control road sections (SS1 and SS2), the sections are underlain by saturated clay layer (Figures 3 and 4) which are weak zones and have moderate resistivity values suggesting that they are vulnerable to failure in future.

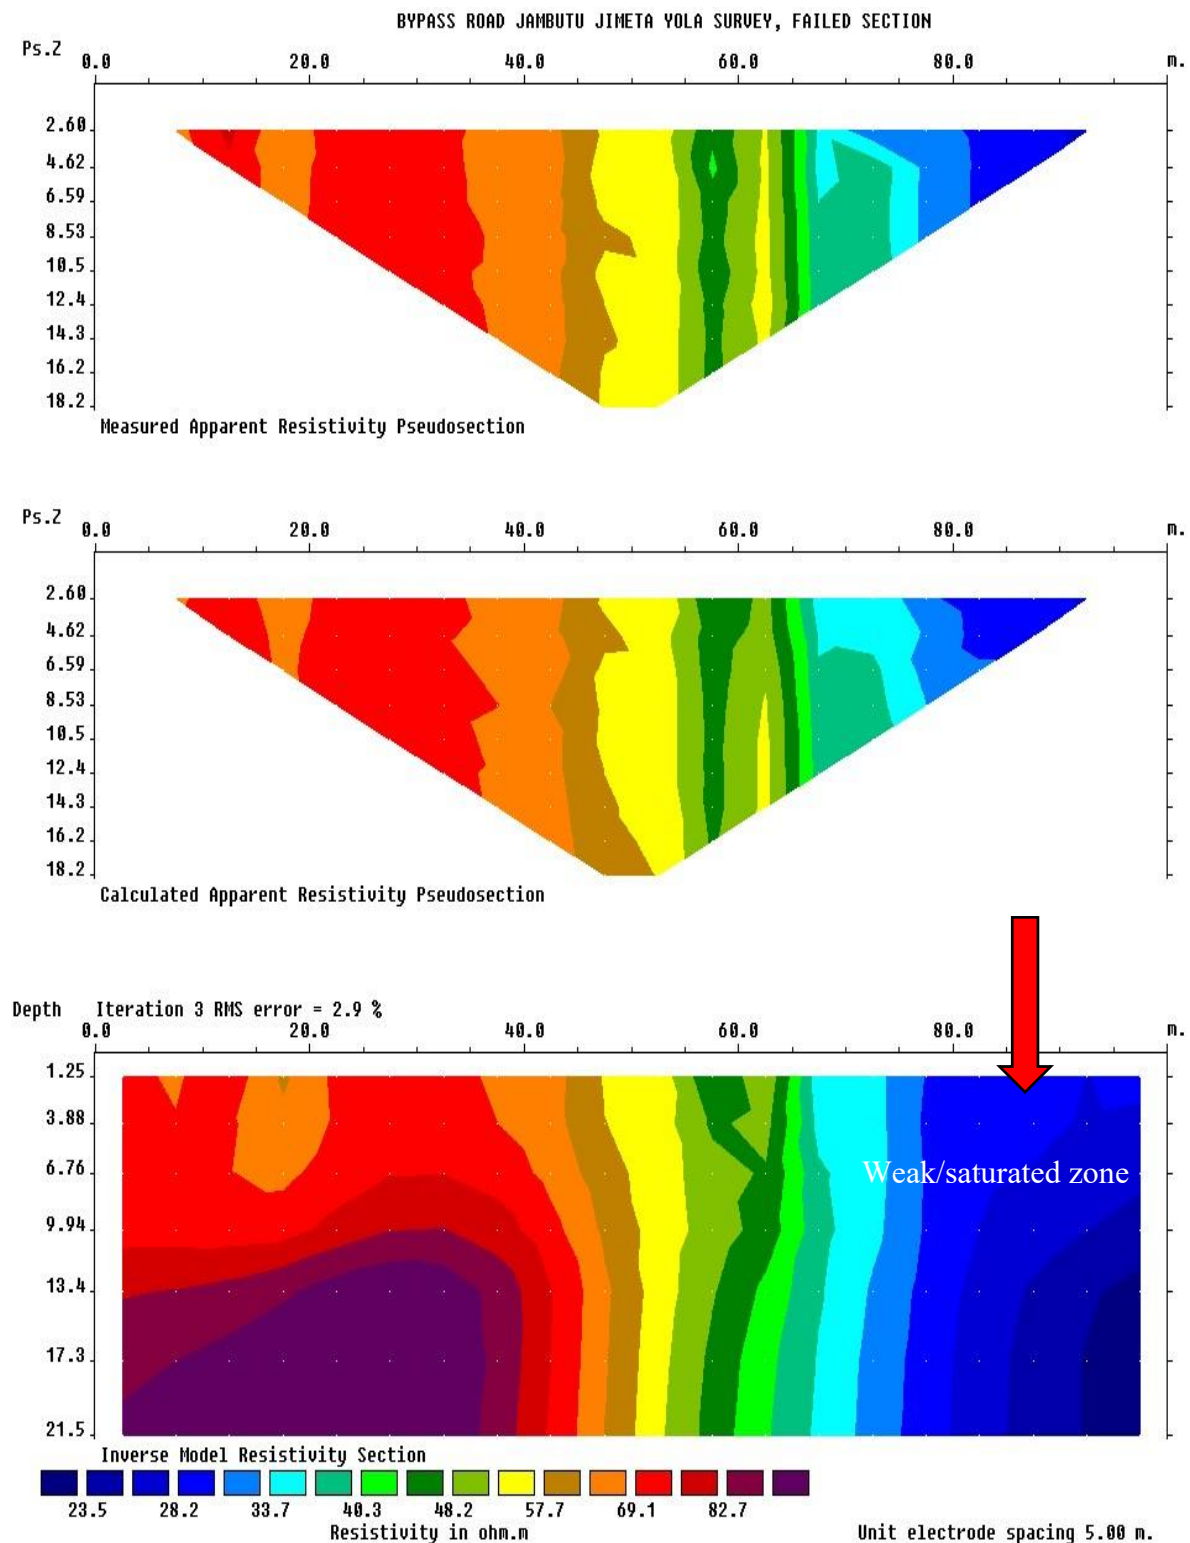
Figure 5: Pseudo-section plots showing the measured apparent resistivity, calculated apparent resistivity and inverse model resistivity section for the Failed Section 1 (FS1)

Figure 5 reveals the resistivity pseudo-section for failed section 1 (FS1), showing a much lower resistivity value than the stable sections 1 (SS1) and 2 (SS2), ranging between 28.5 - 82.7  $\Omega\text{m}$ . This range of resistivity is indicative of an underlying layer of clay and sandy clay (Brian, 1978; Fang & Daniels, 2006; Idornigie *et al.*, 2006) which are considered to be incompetent as pavement foundation materials, because they have the capacity to retain water as result of the high porosity and low permeability (Fang & Daniels, 2006; Ike *et al.*, 2024; Ike *et al.*, 2023; Santamarina *et al.*, 2001). The underlying material is therefore not good enough as subgrade course material, since it absorbs water, swells and exhibits low bearing capacity, causing differential settlement of the overlying pavement leading to road collapse (Aderemi & Adeola, 2021; Bisong *et al.*, 2023). Resistivity of this failed road section (FS 1) ranging between 28.5-82.7  $\Omega\text{m}$  is typical of soils with high moisture content (poor drainage), poor compaction, high porosity and poor stability, low load-bearing capacity and subsequent failure with increased risk of erosion and deformation (Adeyemi & Wahab, 2008; Akpoyiboa *et al.*, 2025; Fang & Daniels, 2006). According to Akpoyiboa *et al.*, (2025), a substantial quantity of clay or clayey soils in the subbase or subgrade course material ensures that lateritic soil stability, strength, and integrity are not guaranteed especially when water is present.

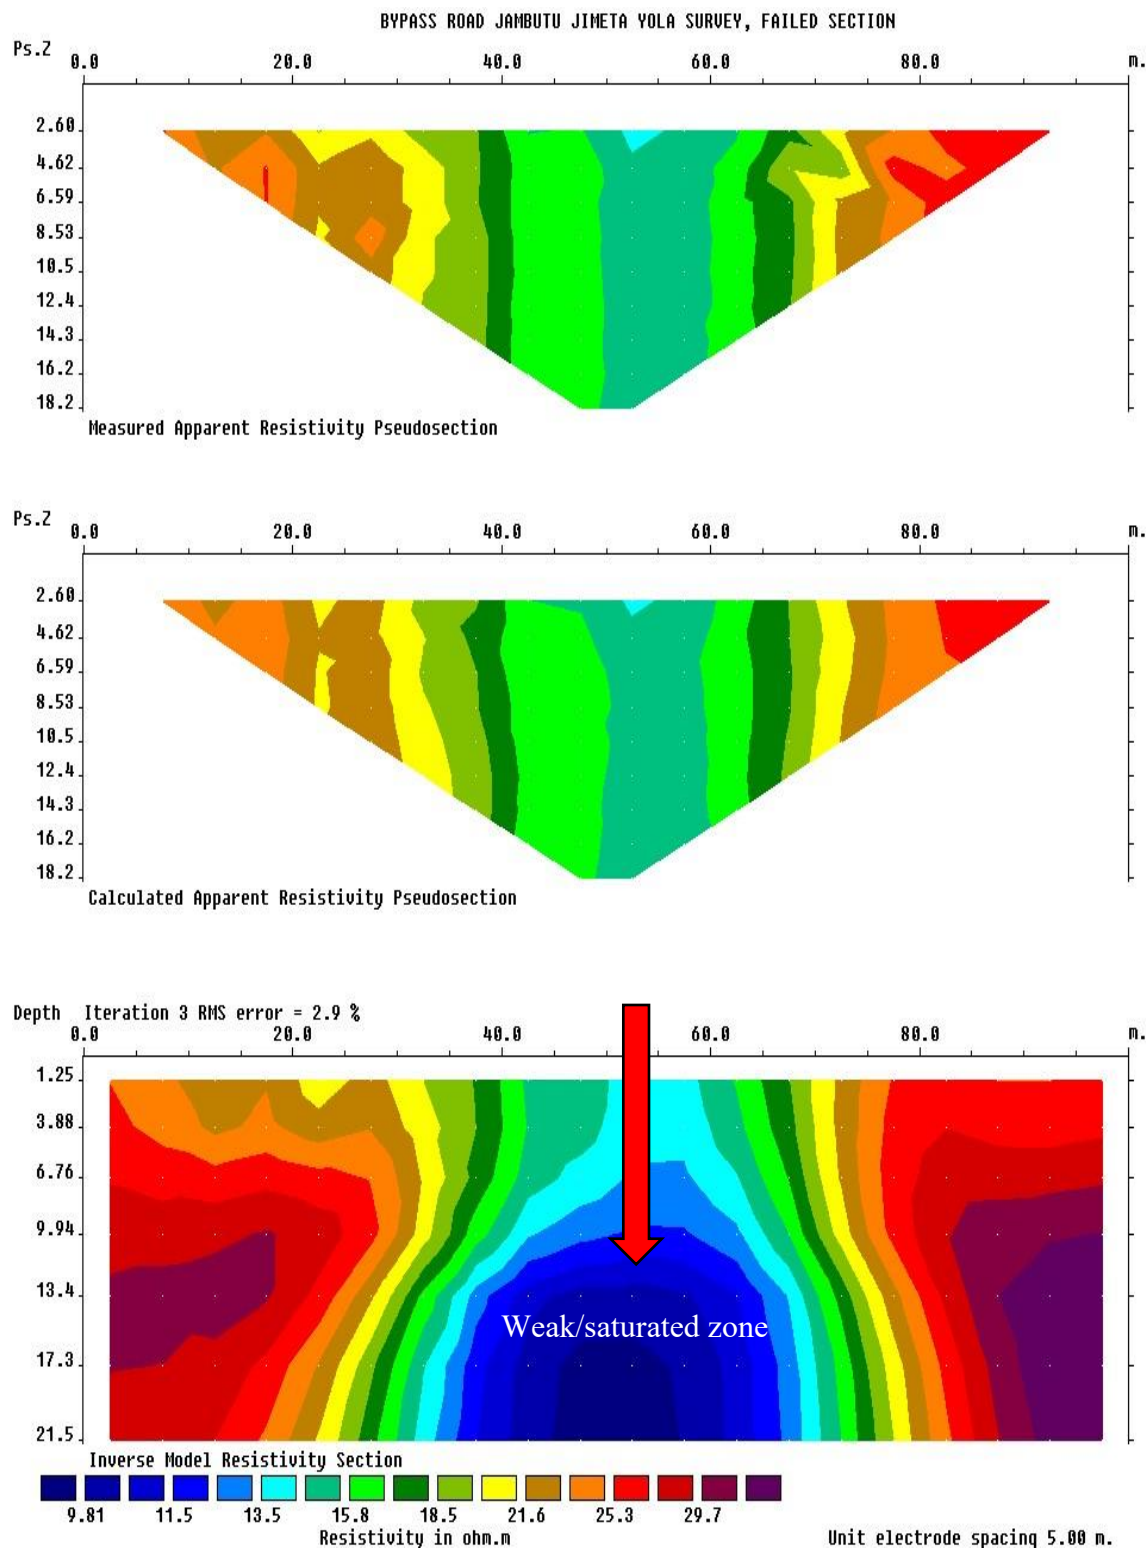
Figure 6: Pseudo-section plots showing the measured apparent resistivity, calculated apparent resistivity and inverse model resistivity section for the Failed Section 2 (FS2)

Figures 6, 7 and 8 shows the resistivity pseudo-section for the failed section 2 (FS 2), 3 (FS 3) and 4 (FS 4) respectively. Their resistivity values ranges between 9.81 - 29.7  $\Omega\text{m}$ , 7.84 - 21.9  $\Omega\text{m}$ , 11.9 - 21.5  $\Omega\text{m}$  respectively. These ranges of low resistivity values signify the presence of weak zones of saturated moist clay, silty sand/sandy clay (Momoh *et al.*, 2008; Reynolds, 1998; Telford *et al.*, 1990) and are known for poor stability, risk of erosion and deformation.

According to Bisong *et al.*, (2023) and Rafiu *et al.*, (2020), any resistivity value as low as less than 30  $\Omega\text{m}$  is considered a weak zone, this section of the road is therefore situated on an incompetent foundation material, hence can be adjudged to be responsible for the damages

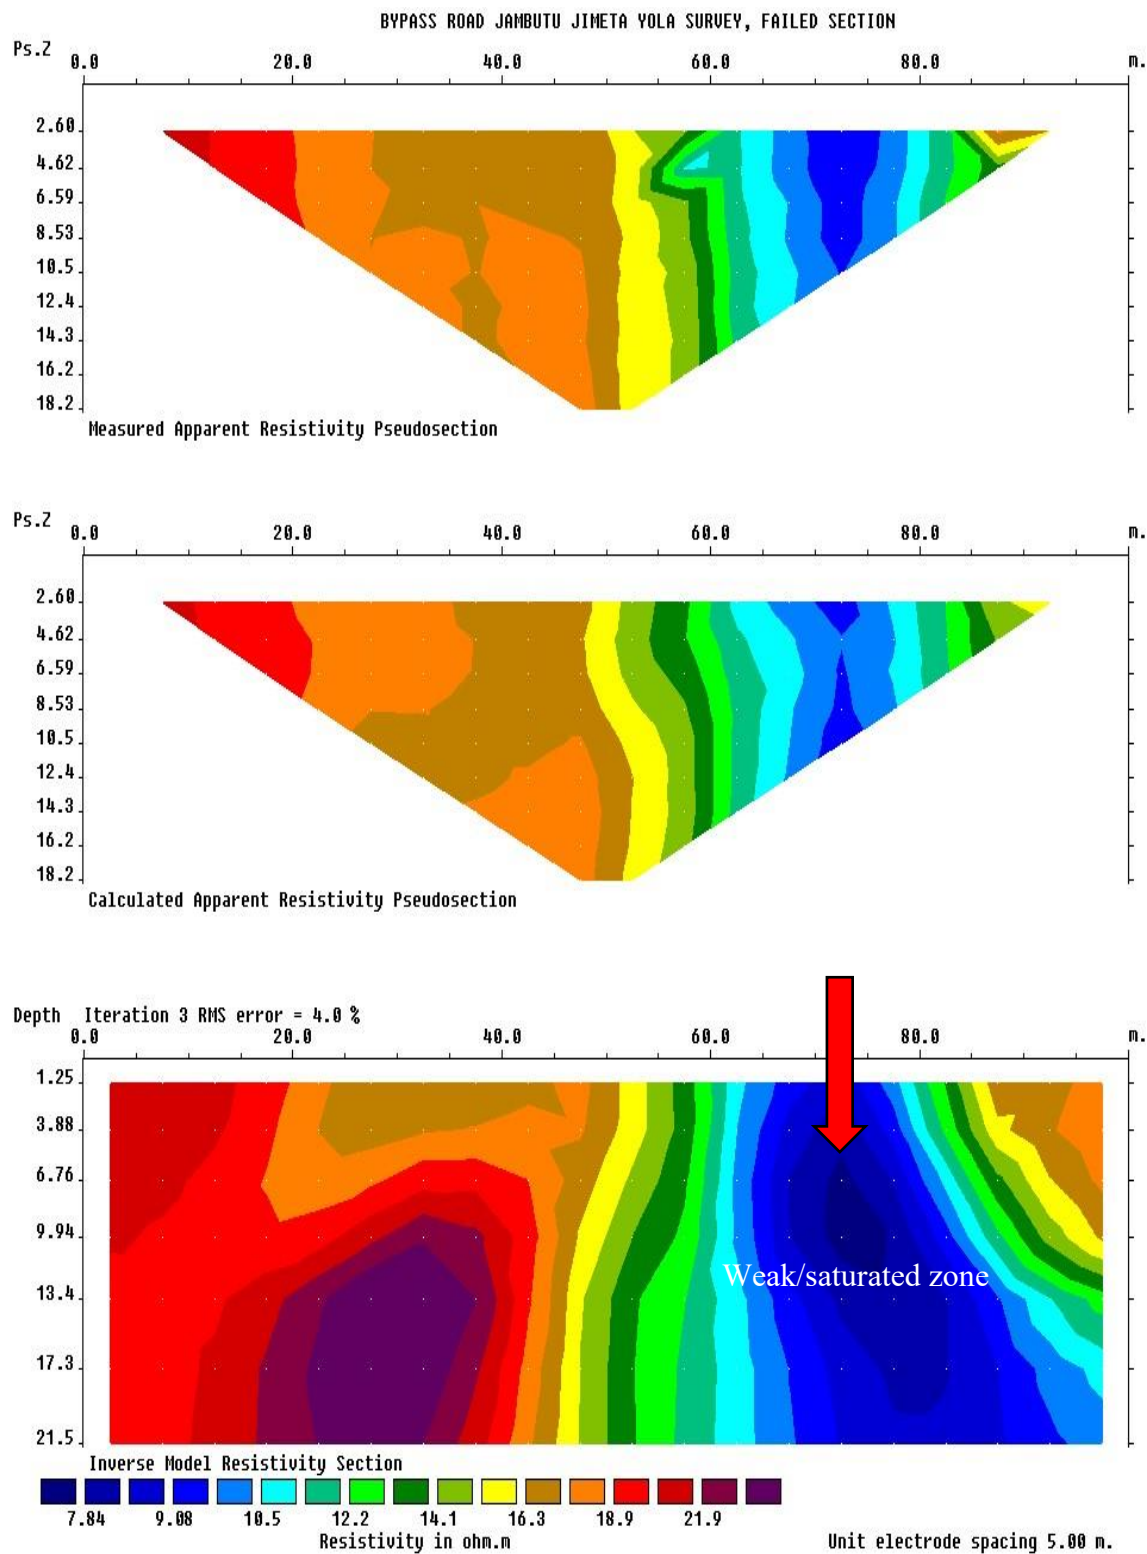
Figure 7: Pseudo-section plots showing the measured apparent resistivity, calculated apparent resistivity and inverse model resistivity section for the Failed Section 3 (FS3)

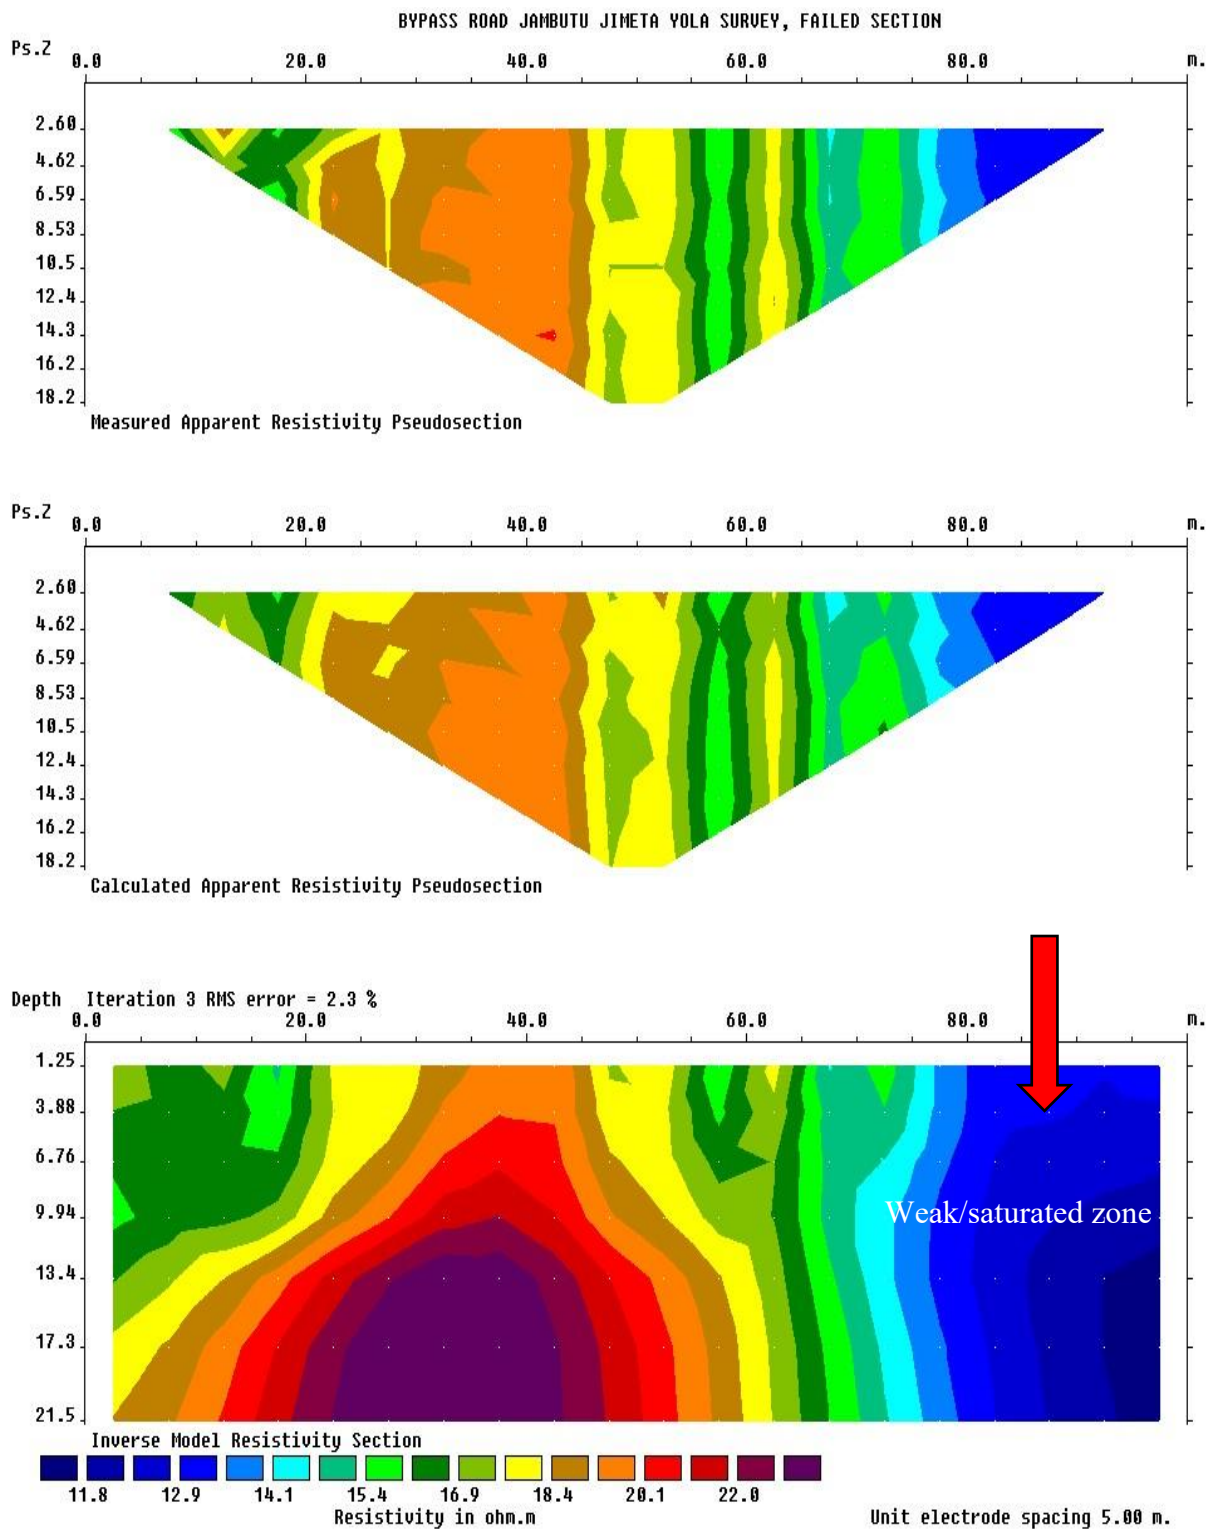
Figure 8: Pseudo-section plots showing the measured apparent resistivity, calculated apparent resistivity and inverse model resistivity section for the Failed Section 4 (FS4)

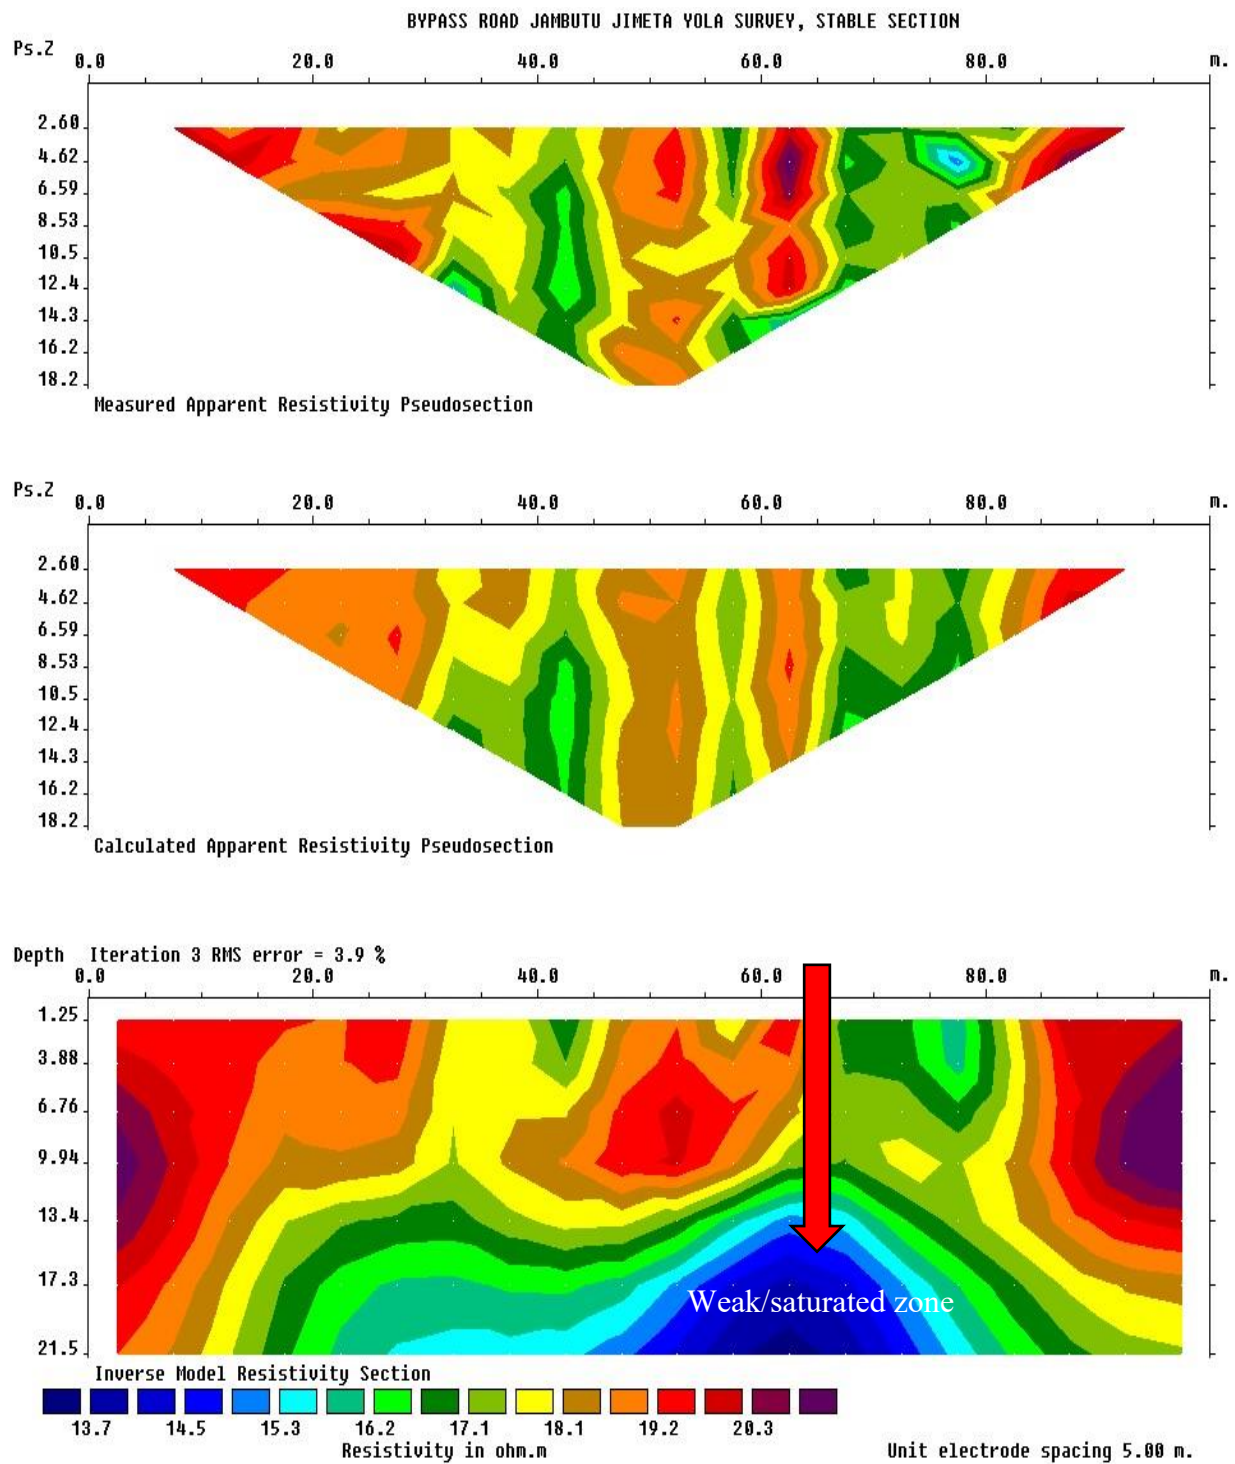
Figure 9: Pseudo-section plots showing the measured apparent resistivity, calculated apparent resistivity and inverse model resistivity section for the Stable Section 3 (SS3)

Figure 9 shows the resistivity pseudo-section for stable section 3 (SS3), with a layer of resistivity value ranging between 13.7 - 20.3  $\Omega\text{m}$  overlying a weak zone. Figure 10 on the other hand, reveals resistivity pseudo-section for stable section 4 (SS4), with layer of resistivity value ranging between 14.5 - 21.9  $\Omega\text{m}$ , overlying a weak zone. These range of resistivities 13.7 - 20.3  $\Omega\text{m}$  and 14.5 - 16.3  $\Omega\text{m}$  for the SS3 and SS4 respectively are typical of clay, silty or sandy clay which has the tendency to retain moisture due to high porosity and low permeability (Aderemi & Adeola, 2021). Though there was no visible failure observed on the pavement surface, the low resistivity of the underlying material makes the pavement vulnerable to failure in future. Results of the geophysical survey of our study are in agreement with those of Adiat *et al.* (2017); Eebo and Abiodun (2021); Nnamdi *et al.* (2019); Ademila (2017); Ademila and Olayinka (2020); Akpoyiboa *et al.*, (2025); Avwenaghegha *et al.* (2021); and Jekayinfa and Osinowo (2021), whose studies extensively proved the troublesome influence of clay or clayey underlying earth material as one of the common causes of road pavement failure having low resistivity value. Such layers are saturated and weak zones, hence cannot support vehicular loads. In particular, clays expands and contracts seasonally, resulting in several cracks and deformations on the road as a result of its low shear strength and compressibility (Adeyemi & Wahab, 2008; Akpoyiboa *et al.*, 2025; Egwuonwu *et al.*, 2011). According to Nnamdi *et al.*, (2019), moderate, high and low resistivity soils are indicative of partially stable, very stable and failed sections of the road respectively. The overlap in the resistivity of different rocks and soils is because their resistivities are dependent on factors like porosity, clay content, degree of saturation and the concentration of electrolytes/dissolve salts (Lowrie, 1997). Most of the resistivities were less than 100  $\Omega\text{m}$  (Figure 5, Figure 6, Figure 7, Figure 8, Figure 9 and Figure 10) while a few others were slightly above 100  $\Omega\text{m}$  (Figure 3 and Figure 4). Groundwater usually has resistivity between 10  $\Omega\text{m}$  to 100  $\Omega\text{m}$  (Reynolds, 1998; Telford *et al.*, 1990) which were observed in Figure 5, Figure 6, Figure 7, Figure 8, Figure 9, and Figure 10. The geo-electrical resistivity method of investigation is therefore effective in mapping the subsurface.

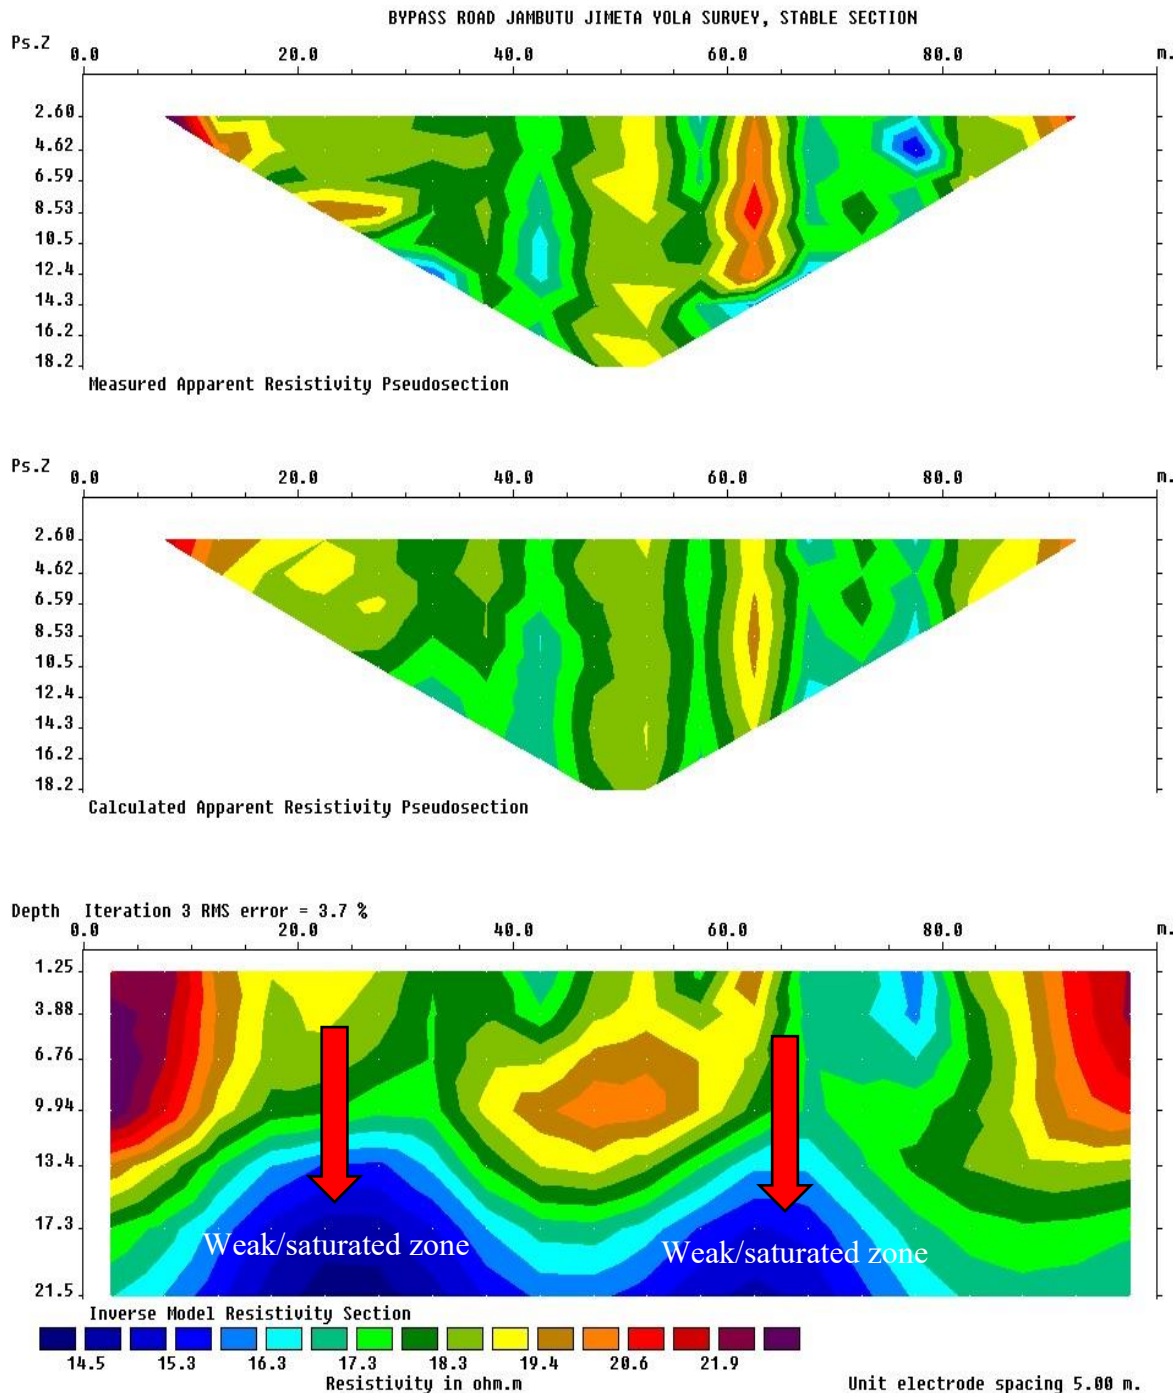
Figure 10: Pseudo-section plots showing the measured apparent resistivity, calculated apparent resistivity and inverse model resistivity section for the Stable Section 4 (SS4)
