## Geophysical Investigation of the Causes of Building Cracks in a Basement Complex Terrain of FUNAAB, Southwest Nigeria

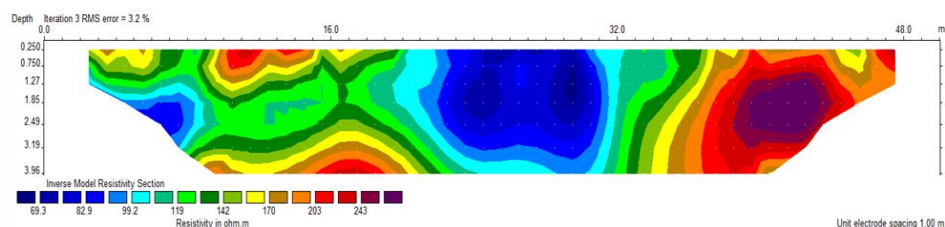
Figure 3a: Traverse 1

Resistivity plot of profile 1 shows a very thin layer of top soil that discontinues between lateral distances of about 21 to 32 m. Evidently from the inversion, the top soil from the profile towards the eastern part of the study area has been washed away by erosion. On profile 2, which is 20 m from profile 1 in the western direction, the top soil becomes distinct exhibiting a thickness of up to about

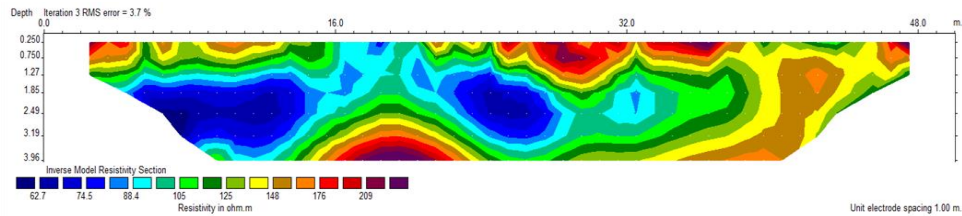
Figure 3b: Traverse 2

0.75 m and resistivity value ranging between 160 and 250  $\Omega\text{m}$ . This layer is underplayed by sandy clay layer that ranges from 0.75 to 1.27 m depth. The lateral discontinuity of the top soil could still be seen however between 16.0 and 21.0 m lateral distance. Profile 3 exhibits a thickness of about 0.80 m with resistivity ranging between 150 and 300  $\Omega\text{m}$ . On this profile, the low resistivity lithology intruding is completely overplayed by the top soil and the compacted clay layer. The top soil of profile 4 is characterized by resistivity value ranging between 130 and 230  $\Omega\text{m}$  with thickness

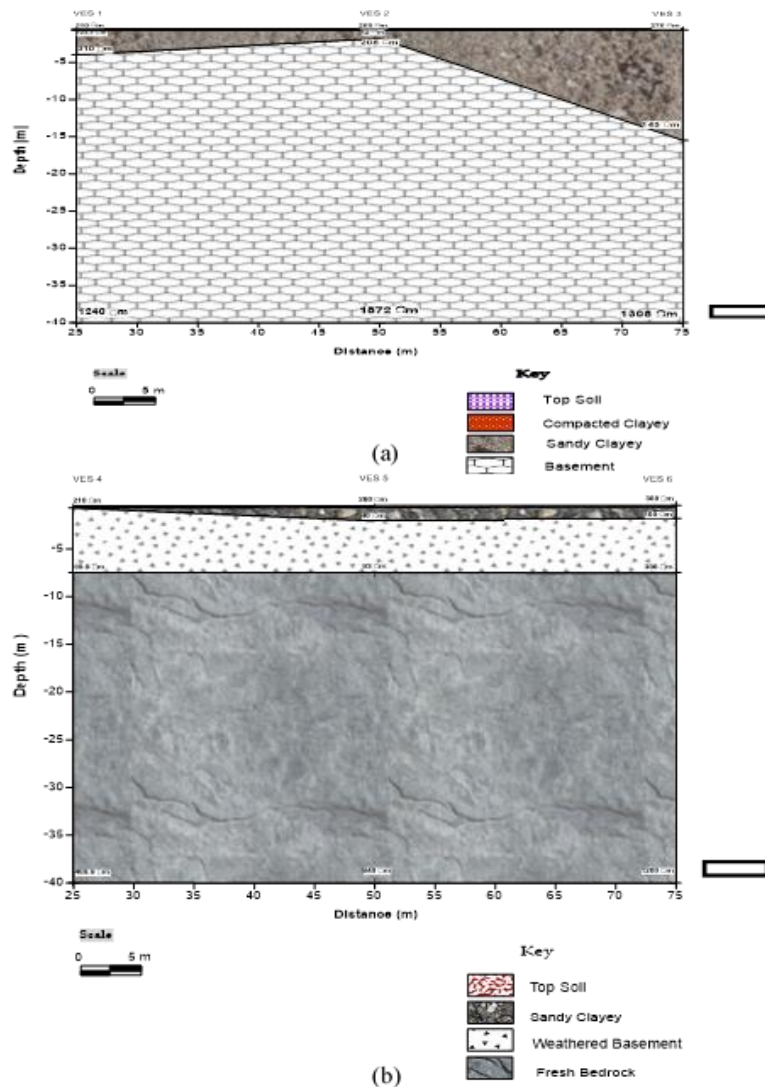
Figure 4: Geosection Plot of VES Combination on (a) Profile 1 and (b) Profile 2

From the geo-electric sections, figure 4(a) and 4(b), the shallow depth of the less dense top soil is clearly evident and it is found in good agreement with the 2D resistivity profiling results.
