Integrated Geophysical and Geotechnical Methods for Pre-Foundation Investigations at Lagos State University of Science and Technology, Ikorodu, Southwestern Nigeria

The recurrence of building collapses and resulting casualties is overwhelming in Lagos State as the state records the highest cases in recent times. This work used geophysical (Ground magnetic (GM) and Electrical resistivity imaging (ERI)) and geotechnical (Dynamic cone penetration test (DCPT)) methods in delineating the subsurface conditions for its competence in foundation structures. Ten profiles of 200 m ground magnetic data were collected at 2 m spacing likewise for Wenner arrays on each profile. DCPT data were collected at points 0 m, 50 m, 100 m, 150 m, and 200m to the depth of 3 m on each of the profiles occupied by GM and ERI. The data obtained were processed and interpreted using RES2DINV software for ERI, Excel package for both Magnetic and DCPT. The ground magnetic results gives the minimum relative magnetic intensity as -1689.78 nT representing possible fault/fractured zone and maximum value of 2943 nT indicating area of competence for foundation structure. ERI results gives a resistivity value ranging fro

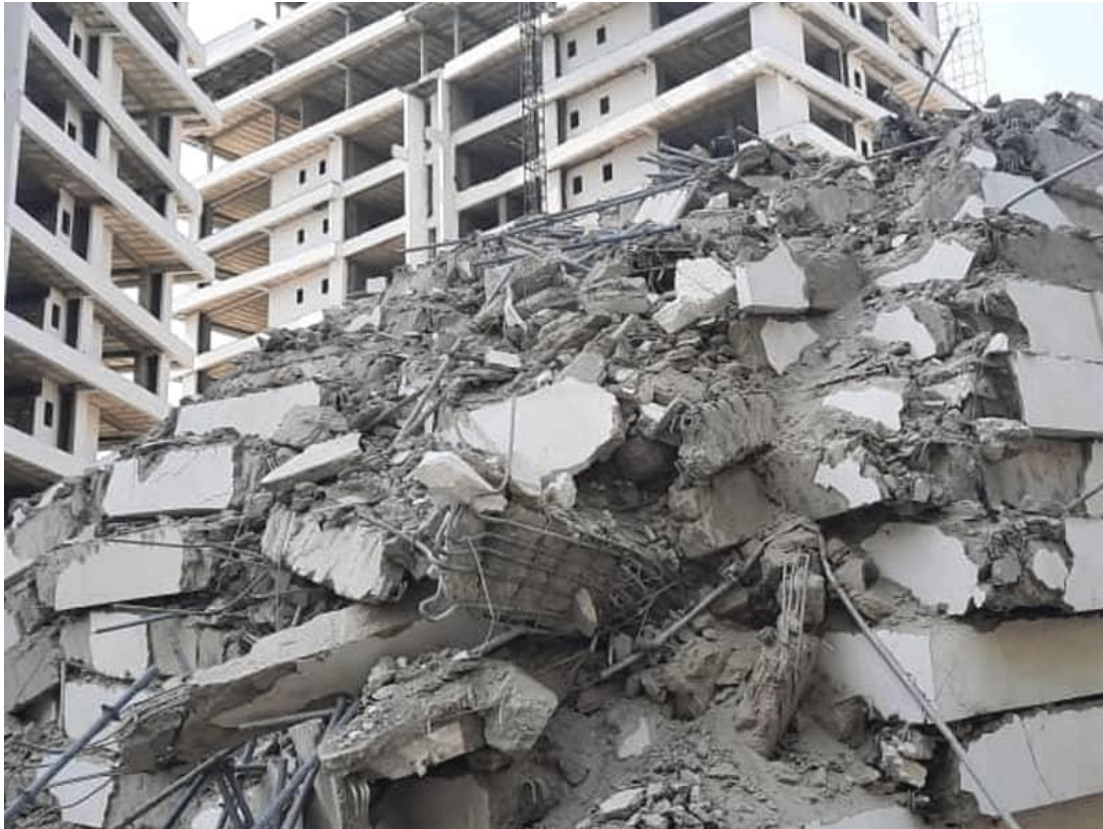
Plate 1: 21-storey luxury apartment building that collapsed during construction in Lagos (GCR, 2024)

The alarming rate of building collapses (plate 1) in Nigeria today is very worrisome. The cost of damages to human lives and infra-structures, as a result of building collapse, may be difficult to estimate. Most often, this collapse could be as a result of improper investigation to determine the competence limit of the subsurface before a building is constructed (Shimobe and Spagnoli, 2020; Adewoyinet *et al.*, 2021). Hence, site investigations are conducted to discover the characteristics of the soil at the particular location towards determining their ability to support structures placed on them (Oghenero *et al.*, 2014; Youdewei and Nwankwoala, 2013; Oyediran and Falae, 2018).

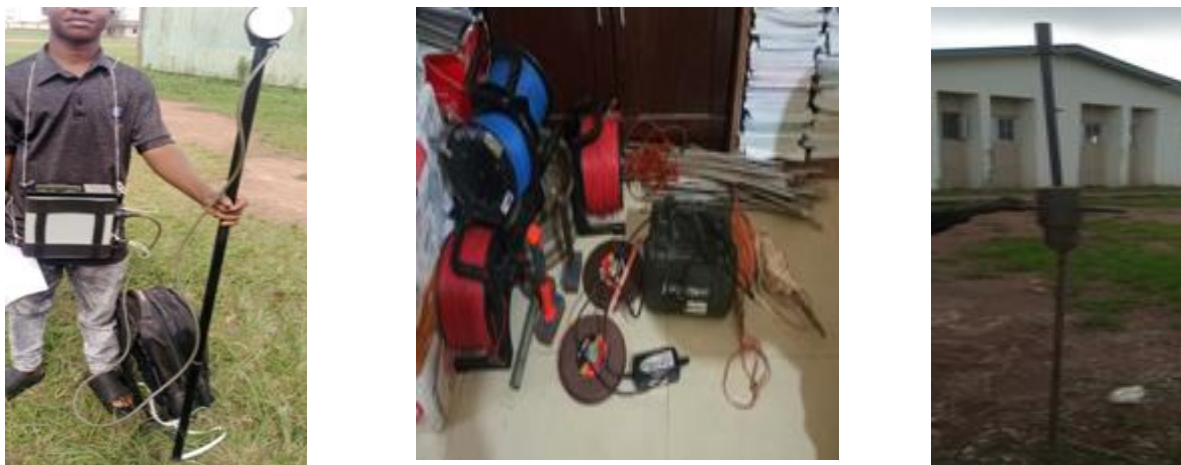
Plate 2: Equipment used for data collection: (a) Proton magnetometer (b) Terrameter and its accessories (c) DCPT apparatus

The instrument used for the ground magnetic survey is the Geometrics Proton Precession Magnetometer, model G- 856 (plate 2(a)) which produces an absolute and relatively high resolution of the field and displays measurement in digital lighted readout. Ten Profiles were established at the study location with Profile length of 200 m and 2 m spacing. The values obtained were corrected for diurnal effect and plotted against horizontal distance for each profile noting the areas of anomalies.

Terrameter, (plate 2(b)) which produces resistance values. Wenner arrays (fig. 3) of profile length 200 m were deployed at 2 m, 4 m, 6 m and 8 m spacing. The resistance values were used to calculate the apparent resistivity values using equation (1).

The DCPT (Dynamic Cone Penetration Test) (plate 2(c)) were conducted at five positions (0 m, 50 m, 100 m, 150 m and 200 m) per profile at maximum depth of 3.0 m. The number of blows and penetration depth were recorded during the DCPT. The California bearing ratio (CBR) values of the study area was evaluated from

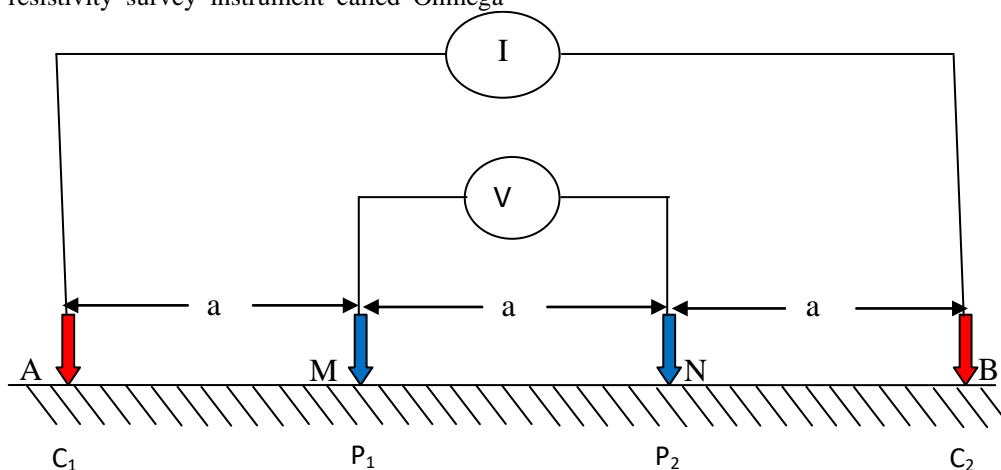
Figure 3: Wenner array arrangement for data acquisition

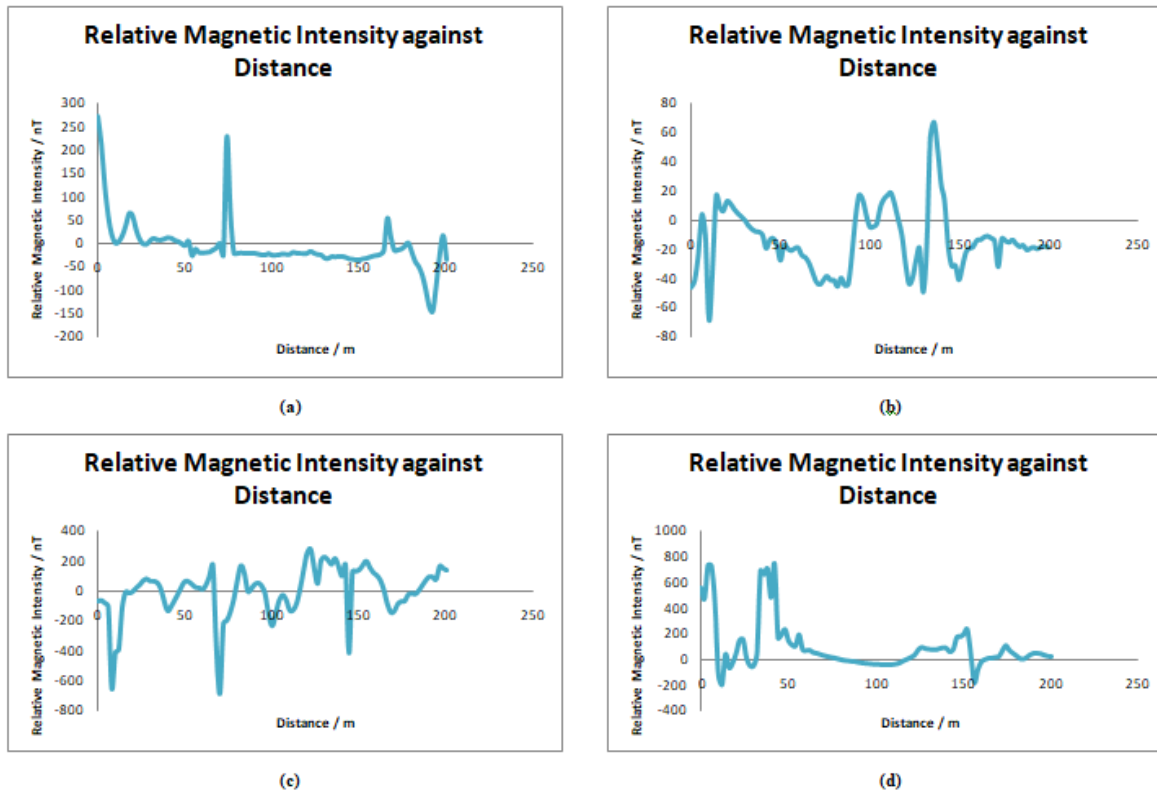
Figure 5: Relative magnetic intensity plots of profiles 5 – 8 (a – d)

Profile five (fig. 5(a)) exhibits magnetic intensity values ranging from -144.01 nT to 273.59 nT while profile six (fig. 5(b)) displays magnetic intensity values within the range of -69.04 nT to 66.97 nT. The magnetic intensity in profile seven (fig. 5(c)) ranges from -681.62 nT to 281.66nT and profile eight (fig. 5(d)) exhibits a magnetic intensity range from -197.01 nT to 740.93nT.

Generally, the relative magnetic intensity values of profiles five to eight revealed were characterised by low magnetic intensity zones corresponding to faults or fractured area that are not suitable for erecting foundation structures. There also exist areas of high relative magnetic intensities corresponding to competent zones suitable for erecting foundation structures.

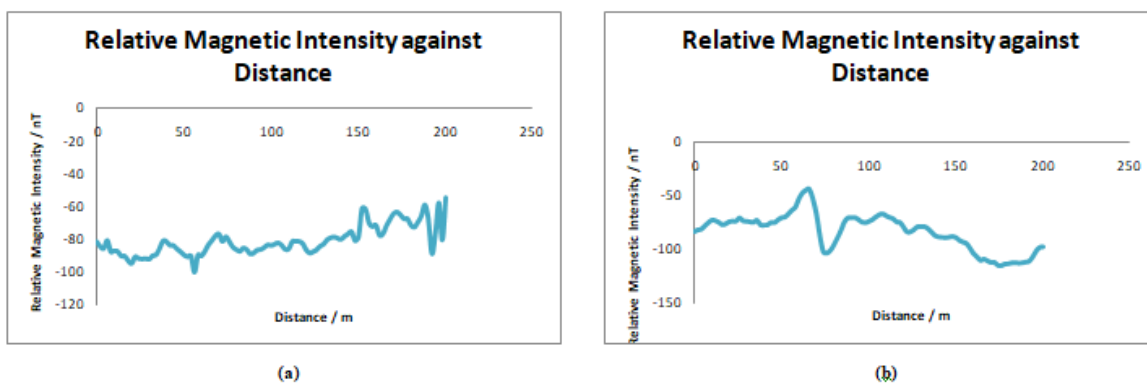
Figure 6: Relative magnetic intensity plots of profiles 9 – 10 (a – b)

Profile nine (fig. 6(a)) exhibits magnetic intensity values ranging from -100.05 nT to -55.04 nT and the magnetic intensity values in profile ten (fig. 6(b)) span from -

115.06 nT to 44.64 nT. Notable weakened zones, which could indicate faults or fractured joints, are visible along the path of profiles nine and ten.
