## GEOPHYSICAL INVESTIGATION FOR ROAD PAVEMENT FAILURES ON NEW EKU ROAD SAPELE, DELTA STATE, SOUTHERN NIGERIA

Avwenaghegha, O. J., Okoh, H. and Ogo, B. O.

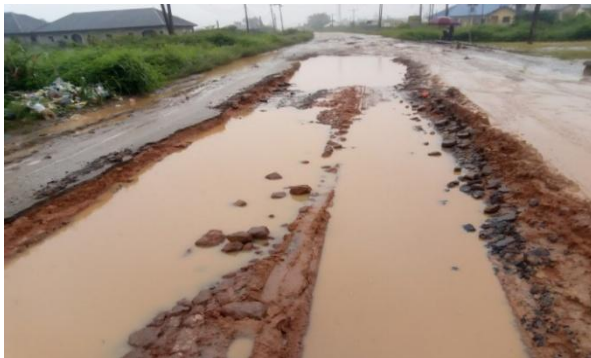
**Plate 1:** Photoshot of failed portions along New Eku Road, Sapele, Delta State, Nigeria

surface. The inversion has clearly shown that the entire area clearly depicts areas of low resistivity which could possibly be the cause of the road failure due to its suspected clayey nature. This very road section is one of the areas where the damaged road showed clear evidence of the suspected clayey soil as seen in Plate 1.
